# **ANALYSIS OF BROWNFIELDS CLEANUP ALTERNATIVES**

## **VILLAGE OF BELLWOOD**

**4901 St. Charles Road**

**Bellwood, Illinois**

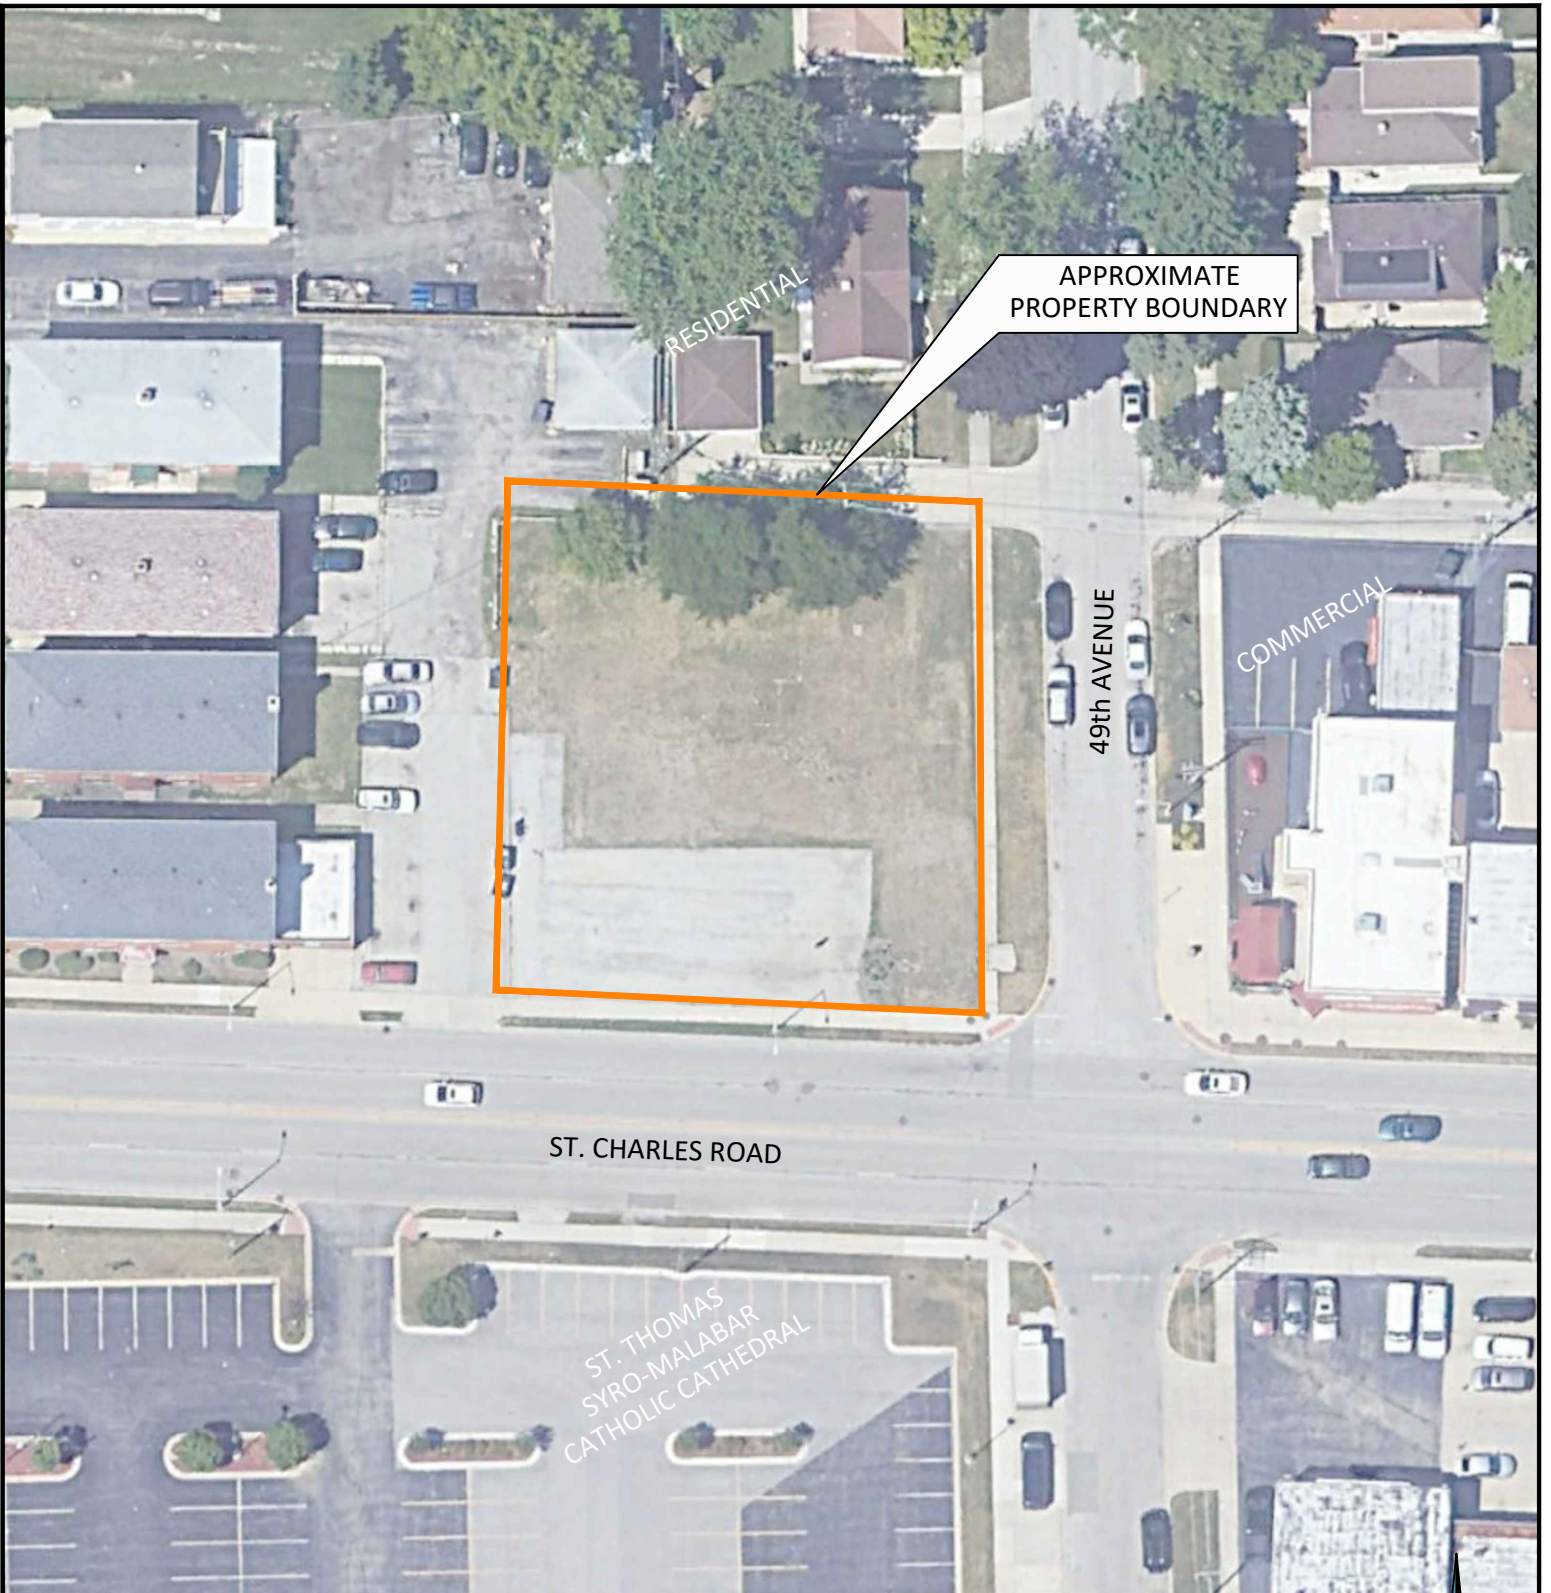
FIGURE 2

APPROXIMATE  
PROPERTY BOUNDARY

### PROPERTY LAYOUT MAP

The Property consists of 0.36 acres of land and is generally bounded by Railroad Avenue to the north, 49<sup>th</sup> Avenue to the east, St. Charles Road to the south, and 50<sup>th</sup> Avenue to the west in Bellwood, Illinois (refer to **Figure 1**). The Property is currently vacant, undeveloped, and primarily grass covered, with the exception of an asphalt-paved engineered barrier in the southwestern portion of the Property (refer to **Figure 2 – Property Layout Map**).
